# Extending equipment life at alumina refinery

Weld overlay cladding and fabrication company Arc Energy Resources has recently completed a complex on-site repair to a set of expansion bellows for an alumina refinery. This article reviews the problems encountered and explores solutions provided.

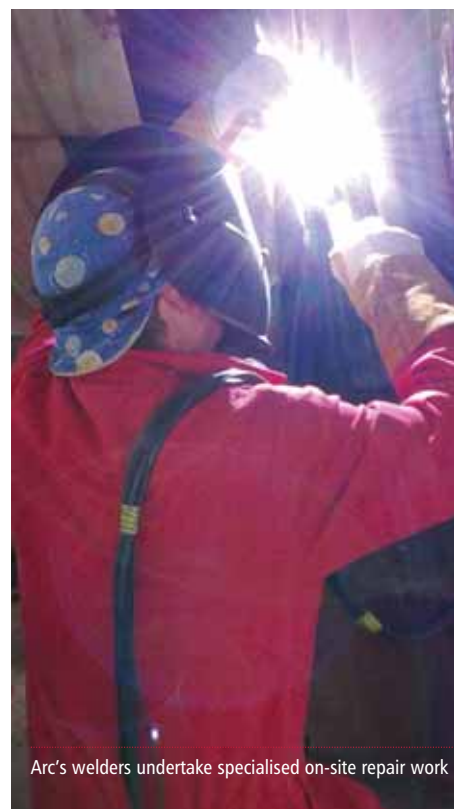
Arc's welders undertake specialised on-site repair work
